"POS" TECH TIP

ALUMINUM HEAT EXCHANGERS • HEATER CORES / RADIATORS

HOW TO LOSE A CUSTOMER - THREE EASY STEPS!

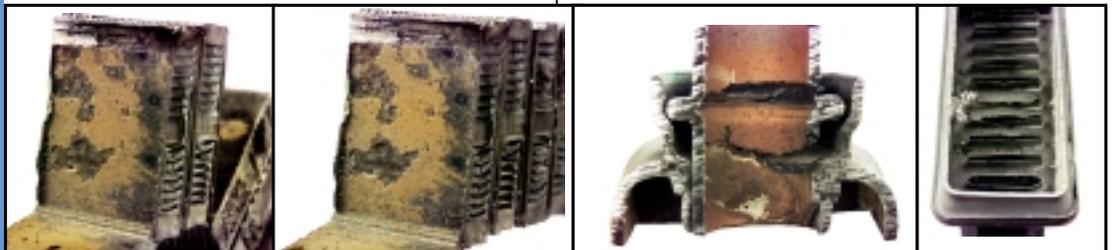
Examples of "pin hole" core leaks caused by contaminated cooling system.

Examples of failures caused by a combination of "Electrolysis" and "Acidic" coolant.

fact, he has made the problem worse by "grounding the heater core", thereby providing a path for the stray electric current in the cooling system to go to ground through the heater core to cause the damage to the heater core. What should he have done? The following diagnostic procedures should lead the installer to a properly serviced system, and restore the vehicle's cooling system to an acceptable condition to allow the vehicle to return to normal service.

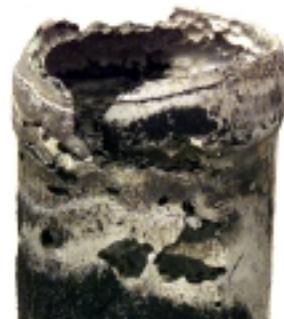
Extreme damage to inlet tubes caused by "Electrolysis and Acidic" coolant.

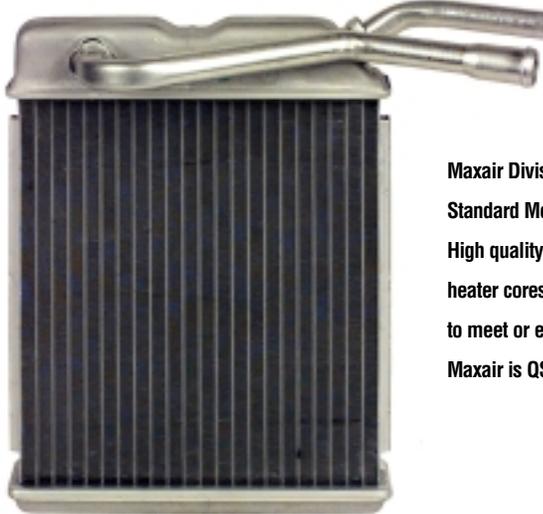
PN 94484

Maxair Division of Four Seasons / Standard Motor Products, Inc.
High quality GM aluminum replacement heater cores manufactured by Maxair to meet or exceed OE specifications.
Maxair is QS9000 / ISO9002 Certified.
